Division of Oil Gas and Mining

Minerals Inspection Report

Mine Name: Cedarstrom Calcite Mine	Permit Number: S/49/0012	Mine Status: Active
Operator Name: Ambro & Sons Inc.	Inspection Date: 03/24/2014	Permit Fees: Paid
Inspector(s): A. Abate	Inspection Time: 4 PM	Bond Amount: \$25,200
Attendee(s): Chris Ennis	Weather: Sunny, 50s	Bond Escalation: 10/21/2014
Inspection Purpose: Assess progress of reclamation work		Prior Inspection: 2/27/2014

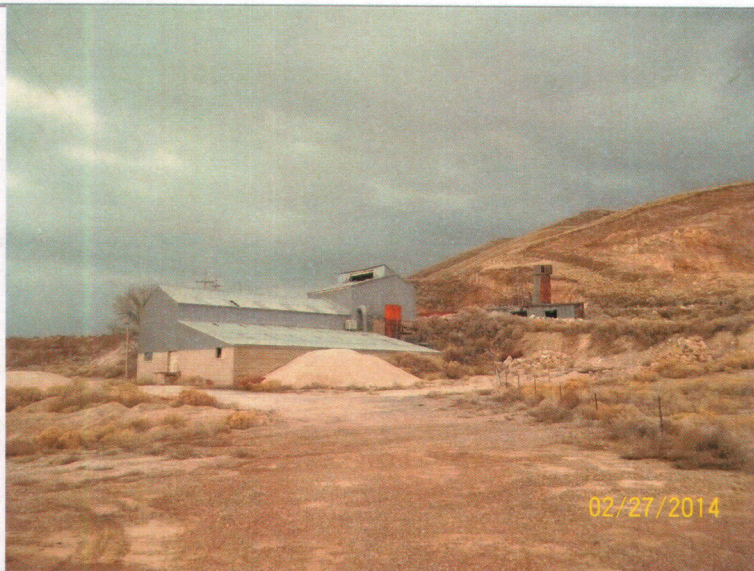
Before Photo of old structures on the property.

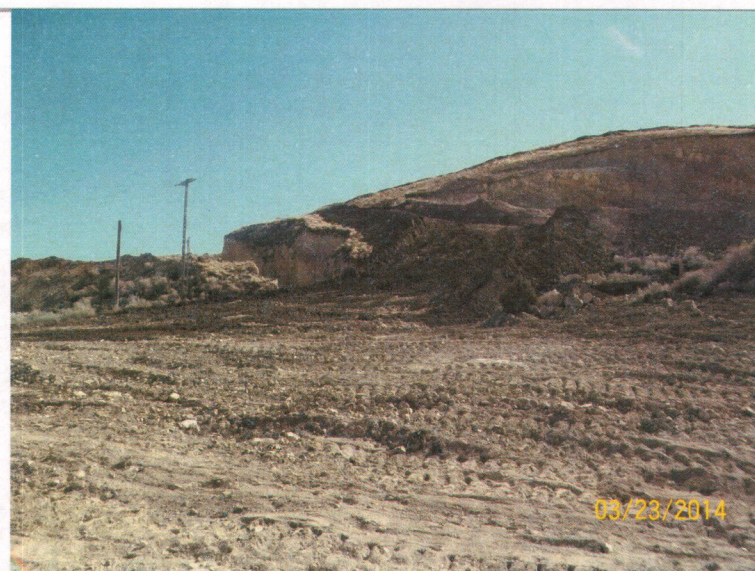
6.	Reclamation	<input checked="" type="checkbox"/>	<input type="checkbox"/>
The progress of the reclamation work is looking terrific. All surface facilities have been demolished and the portal entry area has been buried. The calcite vein seam still needs to be filled in with either soil or blasted rock. The work is expected to finish up in the next few weeks. The operator will seed this spring.

Structures have been torn down and the slope is in the process of being graded.

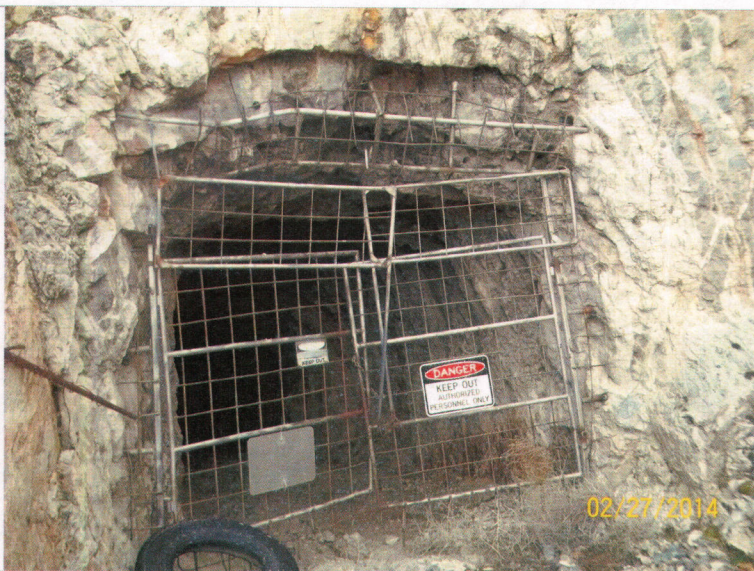
Old Portal on the property

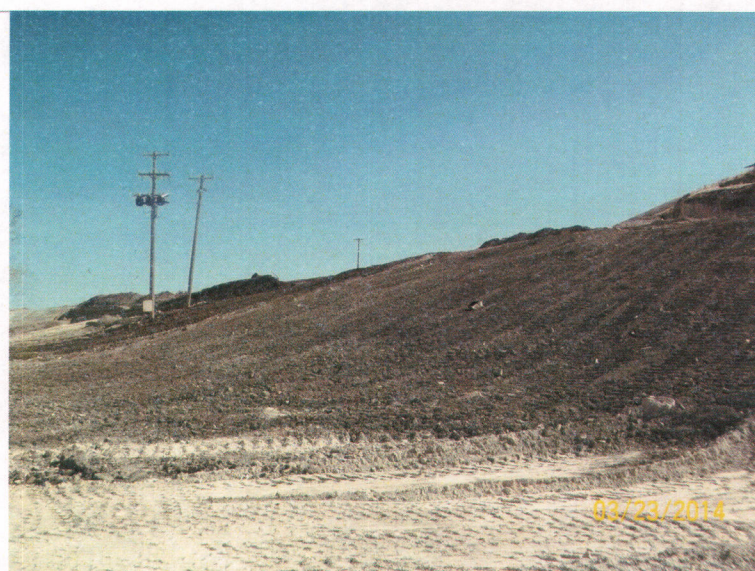
Grading and earthwork are being completed over the next few weeks. A small amount of topsoil was available. The operator will seed this spring.
